मुंबई रेलवे विकास कॉर्पोरेशन लिमिटेड
MUMBAI RAILWAY VIKAS CORPORATION LTD.

Passenger Survey of new age
ICF manufactured MUTP PH-II
EMU rakes with M/s. Bombardier Electrics

APRIL-2015

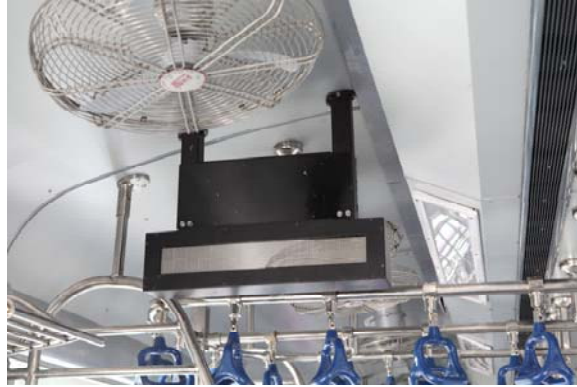
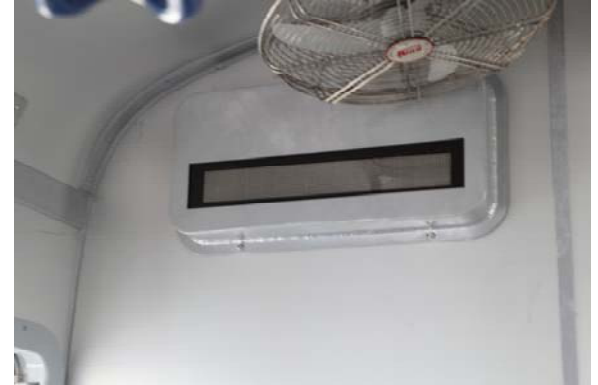
4) Visibility of Display of Passenger Information System:

REMARKS: The location of Passenger Information System (PIS) is such that the view is obstructed by the grab handles due to which it is difficult to read the displayed information.

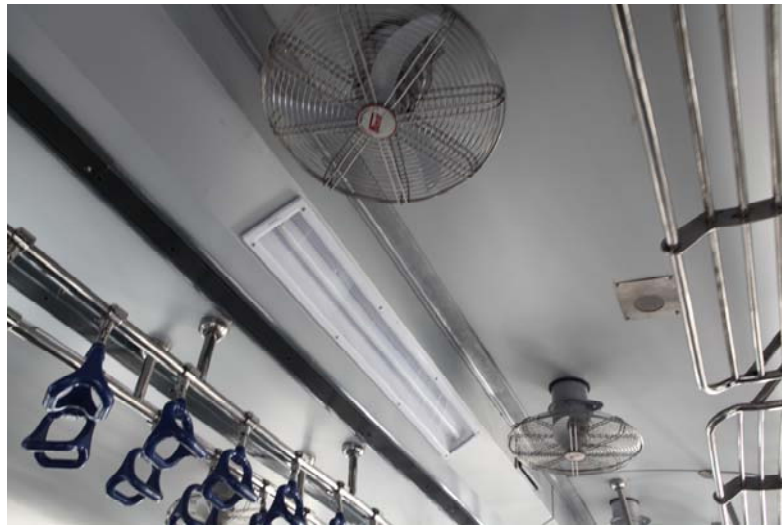
6) Number of fans & other electrical fittings:

REMARKS: In the new rake, the gap between switches & luggage rack is very less, making it inconvenient to operate. There is provision of single fan in the seating area. The demand is for more numbers of fans.

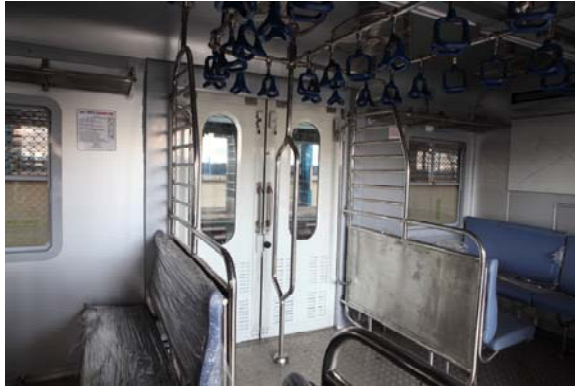
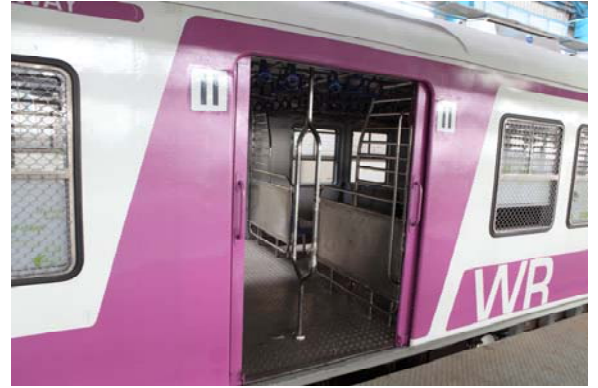
10) Hexagonal center pole at door for boarding /alighting:

REMARKS: 30% Commuters are not satisfied with the hexagonal center pole provided at the door for alighting/boarding. They suggested replacing it with the single rod as provided in the Siemens rakes.
