## **Environmental & Social Management Implementation Audit of the Mid-Section Trespass Control, June 2019 – A Report**

In October 2018, MRVC has successfully bidden-out the works pertaining to the Mid-section Trespass Control along both the Central and Western Railway lines in the city of Mumbai. In all, the investments are clustered into 4 lots or construction packages with Foot-Over-Bridges planned in a number of locations in each of the 4 lots.

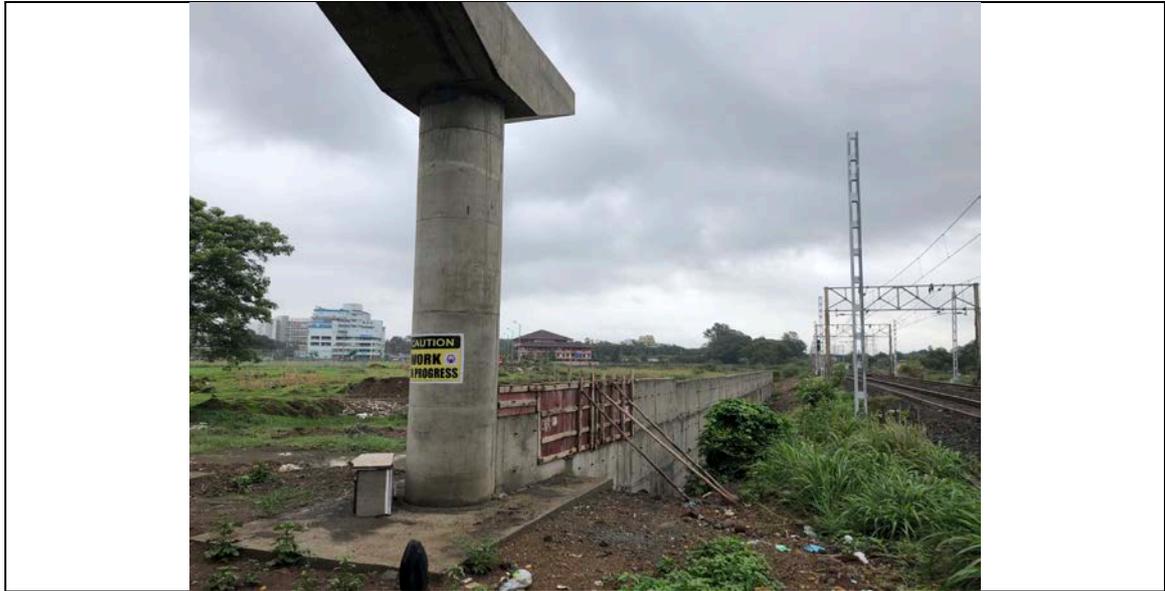
Khandeshwar & Panvel (Mid Section) (Ch. 46/6)

- Khandeshwar & Panvel (Mid-Section) (Ch. 46/6): Pedestrian crossing is a serious issue. On one side of the rail road track, the visibility for pedestrian crossing is really poor. Better night lighting is required; Flag men during the day and watchmen at night are a must.

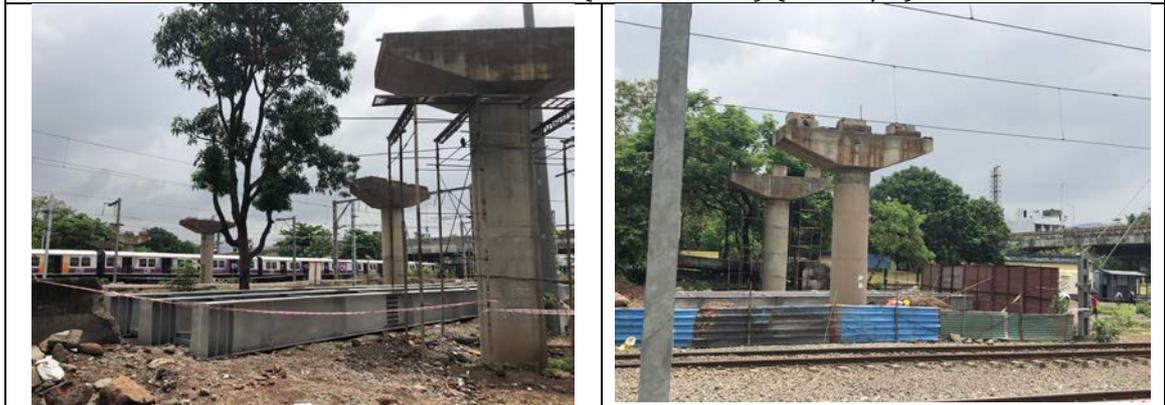
Seawood (Darave) & Belapur (Mid Section) (Ch. 37/14)

- Seawood (Darave) & Belapur (Mid-Section) (Ch. 37/14): Pedestrian crossing is a serious issue. On one side of the rail road track, the visibility for pedestrian crossing is really poor. Better night lighting is required; Flag men during the day and watchmen at night are a must.
